Product Change Bulletin

4-29-2011

GTX

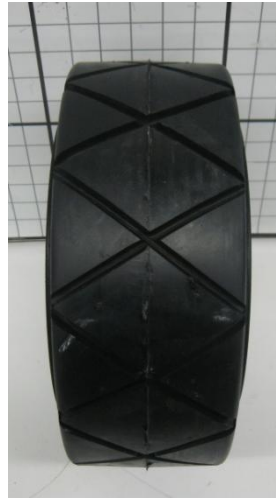
Old 290-6180

Rear tires lose traction when wet

Diamond pattern is the old tire.

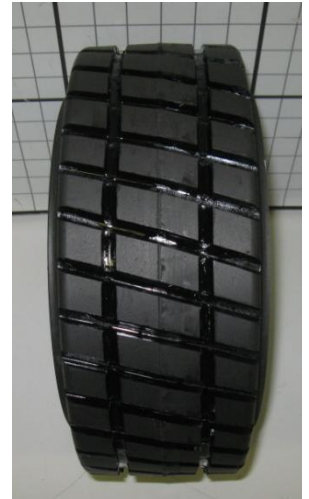
New 250-6180

The new moderate durometer poly tire offers a better balance of traction and reduced rolling resistance. This will lower the current load on the traction motor and thus reduce internal wear on the motor. The new tread pattern is designed for maximum traction and also reduced vibration.

This is a direct replacement of the old tire. Prop machine up with a car jack and use a impact wrench to loosen and take off the lug nuts. Replace with new tire and tighten lug nuts.
