Product Change Bulletin

5-29-2011

XR

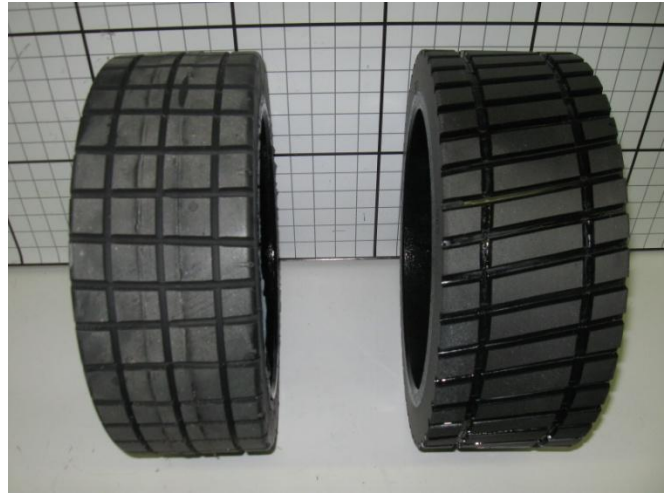
Rear tires lose traction when wet

**Old 370-6180**

**New 370-6186**

The new moderate durometer poly tire offers a better balance of traction and reduced rolling resistance. This will lower the current load on the traction motor and thus reduce internal wear on the motor. The new tread pattern is designed for maximum traction and also reduced vibration.

Square pattern is the old tire.

This is a direct replacement of the old tire. Prop machine up with a car jack and use a impact wrench to loosen and take off the lug nuts. Replace with new tire and tighten lug nuts.
