Product Change Bulletin

5-14-2011

TR, 48

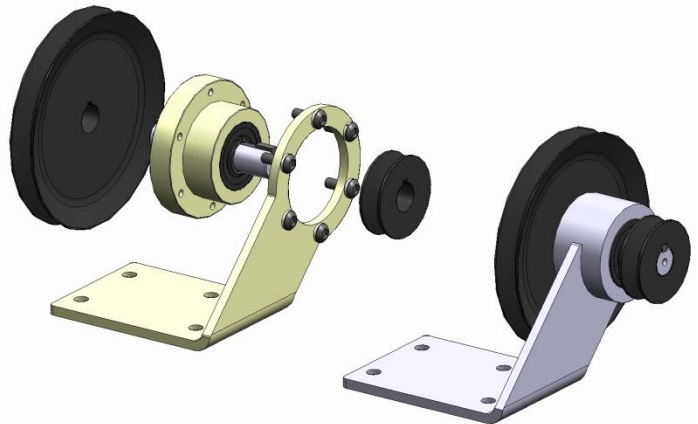
Warped tube that houses the bearings
causing failure

The new design eliminates the weld that could warp the machined tube which contains the bearings. We also made changes to the bearing tube to use 2 instead of 3 bearings and improved engagement between the shaft and the bearings "id". This will increase life expectancy and simplify service.

If the jackshaft has a welded tube that houses the bearings, this is the old part.

This is a direct replacement of the old jackshaft. Open hood to have access to the jackshaft. Remove broom belt from jackshaft's smaller pulley. Find the 5/16" bolts on the motor bracket and loosen them to have some play in the belt from the motor to jackshaft, pull motor towards seat to accomplish this. Loosen the pulley on the motor shaft with a 5/32" allen wrench. Loosen and remove the (4) 5/16" bolts holding the jackshaft onto the frame. Replace with new jackshaft, add the (4) 5/16" bolts, lock washers, and washers, tighten. Put the belt between the motor shaft and jackshaft back on. Align the belt as best you can between the 2 pulleys straight, but do not tighten the set screw yet. Push the motor towards the batteries to make belt tight. While still holding the motor back, tighten 2 of the motor bracket bolts. After 2 are tight you can stop pushing the motor and tighten the remaining 2. Eye ball the belt again and align as straight as you can. Tighten set screw. Put broom belt back on to smaller pulley.
