DATE OF BULLETIN:

10-17-2017

PILOT-HD GTX XR

Shroud Wipers moving out of adjustment over time

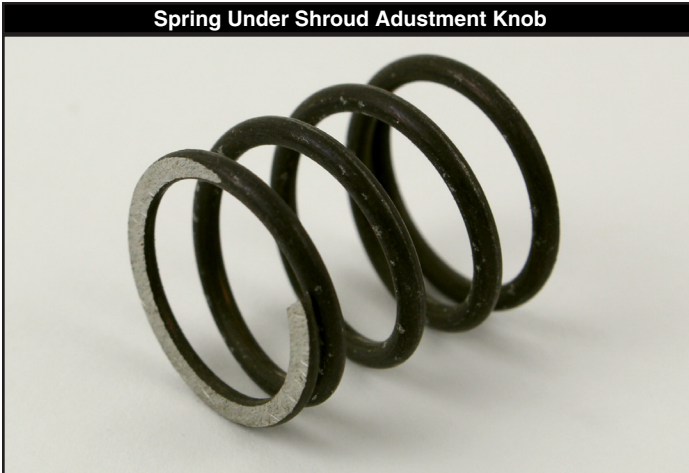
Spring Under Shroud Adjustment Knob

All Disk Rider Scrubbers include new Rubber Washer (Part #: H-4440040) and Support Spring (Part #: 4-386) surrounding the Shroud Adjustment Knob. The Spring that is supported by the Deck, ensures that the Adjustment Knob will not self adjust down over time from machine usage. The Rubber Washer that now sits on top of the Adjustment Knob is to reduce rattle with the machine in operation.

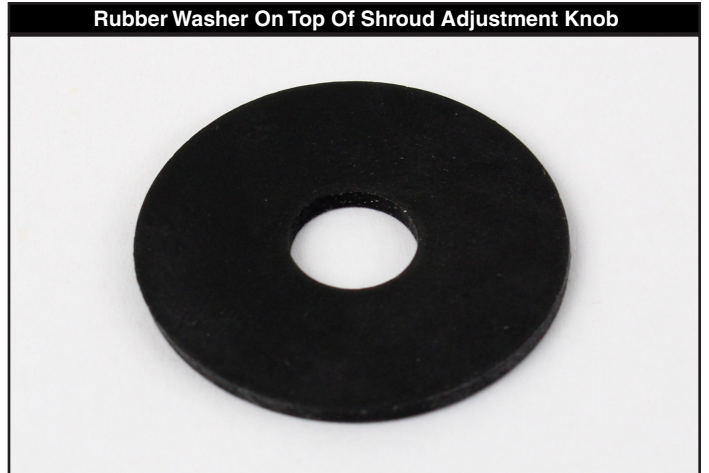
Rubber Washer On Top Of Shroud Adjustment Knob
