Our walk-behind Magnum and MiniMag scrubbers along with our rider XR and GTX series scrubbers will now be shipping with a new recovery tank feature. We have added a part to control and eliminate the splashing caused by the recovery water being discharged into a full debris laden drain saver. Although this splashing does not affect the performance and only happens with a full drain saver the visibility into the tank and overall appearance was not good. Installation of the part on older models takes under a minute and requires no tools.

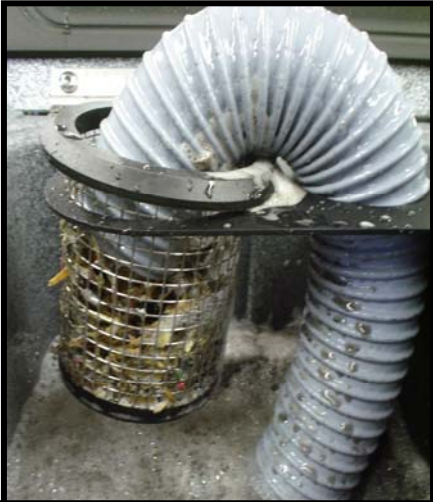
Discharge water in a full drain saver resulting in difficulty viewing inside the tank.

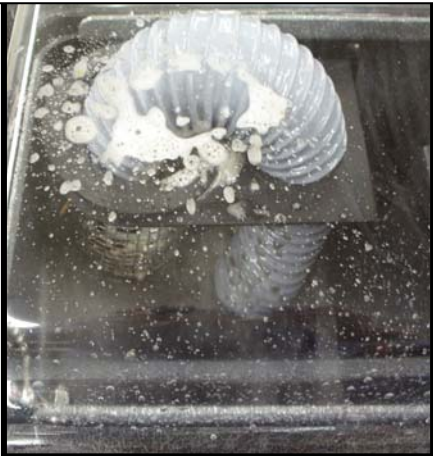
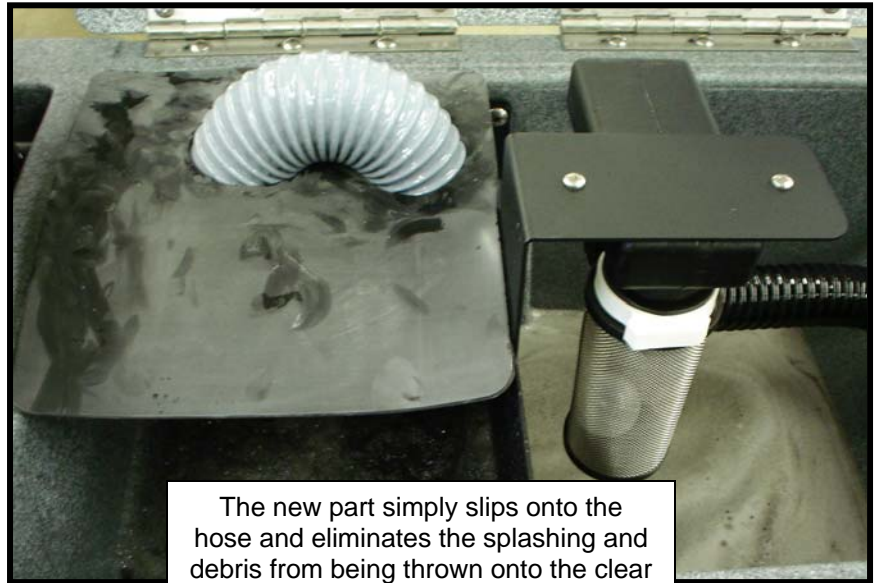
The new part simply slips onto the hose and eliminates the splashing and debris from being thrown onto the clear lid.

The part number is **370-1129**
