Product Change Bulletin

MiniMag, Magnum, GTX, XR

Warping or bending of the recovery tank lid

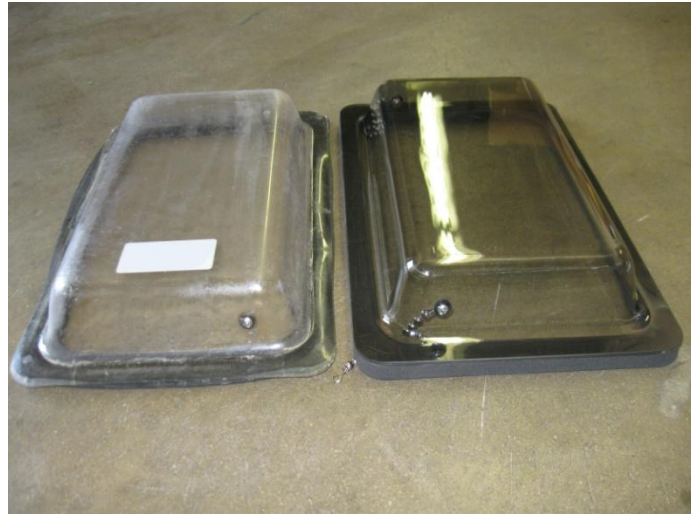
The changes made to the recovery tank lid are not only being tinted but it has a higher temperature resistance (270F vs 170F with clear lid). Also the tank lid gaskets have improved adhesion and the lids have more surface area for the gaskets to attach to.

Warped clear recovery tank lid, lid is not sealing.

190-1410D

This is a direct replacement of the clear plastic lid. Remove the 2 screws holding the recovery lid to the metal tank lid and replace with new lid.
