Product Change Bulletin

MicroMag, MiniMag, Magnum, GTX,
XR

Foam causing the vacuum motor to be shut off to soon.

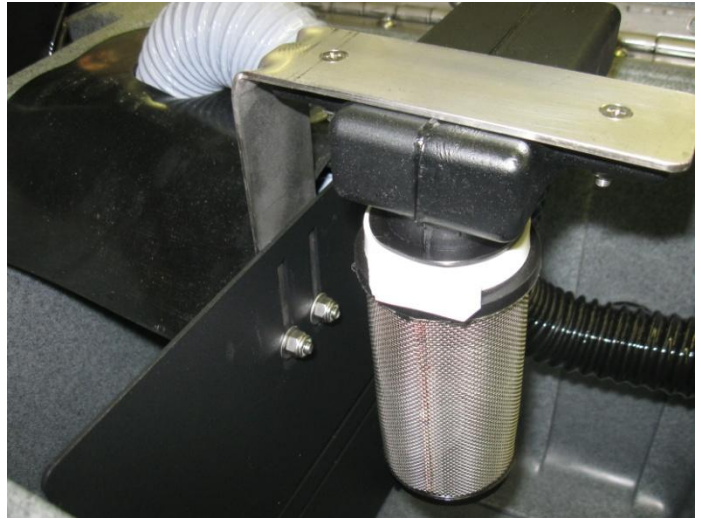
A solid, one piece baffle without the adjustment slots is the old part.

This is a direct replacement of the old part.
