XR Vac Filter & Tank Updates

Type of Bulletin: Product Change Bulletin

Models Affected: XR Rider Scrubber

XR Vac Filter Update

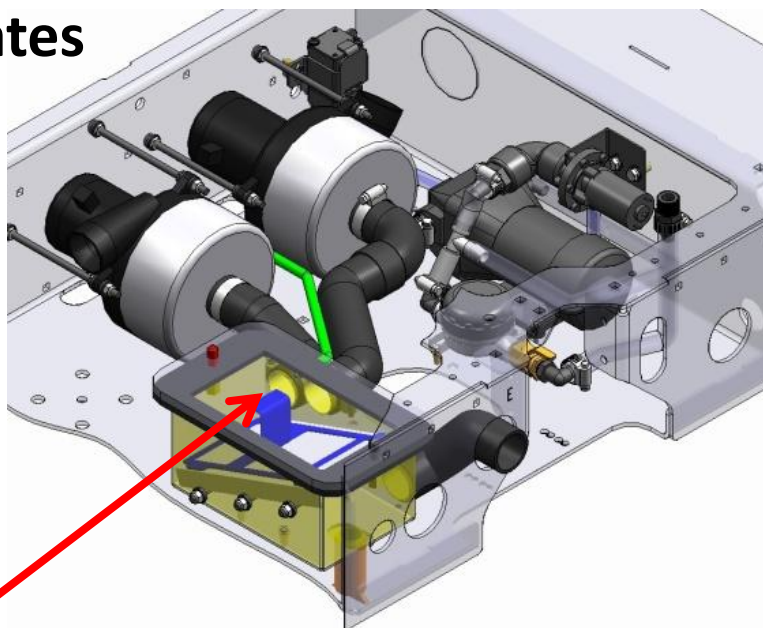
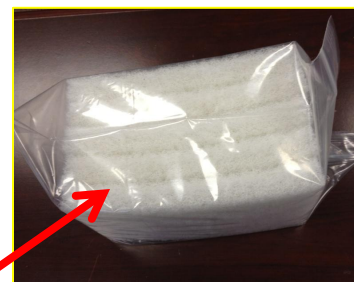
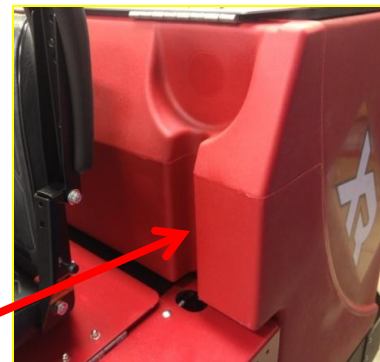
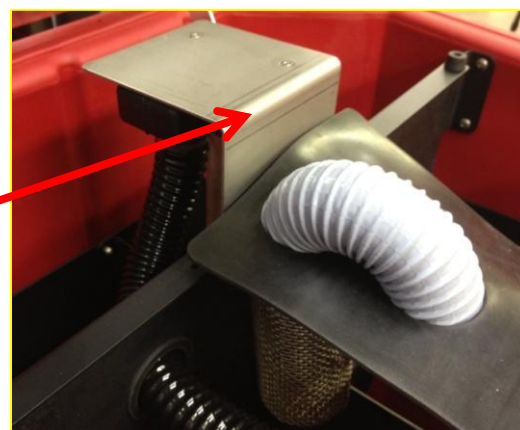
A 3D CAD model of a mechanical assembly, likely a pump or motor unit, shown in a cutaway view. The assembly is mounted on a light gray base plate. It features a large black cylindrical component, a smaller black cylindrical component, and a complex network of black and silver pipes and fittings. A yellow rectangular box highlights a specific component, which appears to be a small blue and yellow valve or fitting. A red arrow points to this highlighted component. The model is rendered with realistic shading and textures, showing various bolts, screws, and structural details.

Filtered Air: Air has passed through filter, removing dust and small debris.

Filter Plate: Must be installed with tab facing indexing pin. Secures

Recovery Tank
Potentially "dust" air is pulled from Foam Float Scraper

Disposable “white” Filter:
Traps dust and foam pulled through Rec. Tank screen.

Unloader Valve: *Drains out moisture from Box*

Correction: . The new Vacuum filter box will protect the vacuum motors further, but does require regular inspection and filter replacement. The Box still contains a drain valve at the bottom to release fluid when the vacuum motors turn OFF. The vacuum motors are now mounted in the opposite direction, which eliminates the potential for a customer to catch the hopper on cylindrical decks, and thus difficult to detect vacuum leaks.

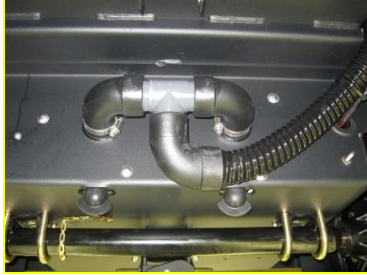
Older Style: *Had Vacuum motors mounted forward.*

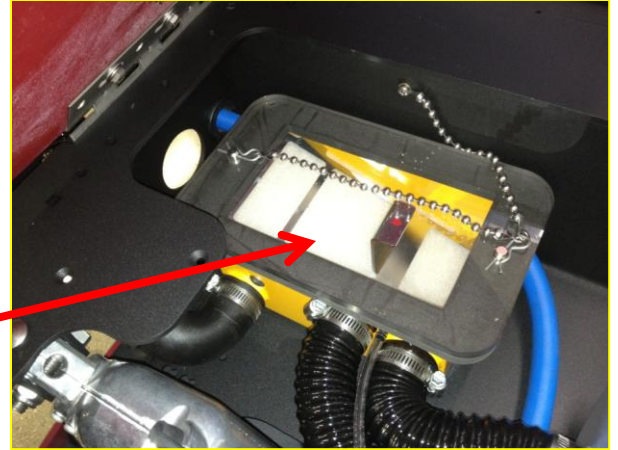
Cover Off : *Reveals the metal grill to hold filter down and large white filter.*

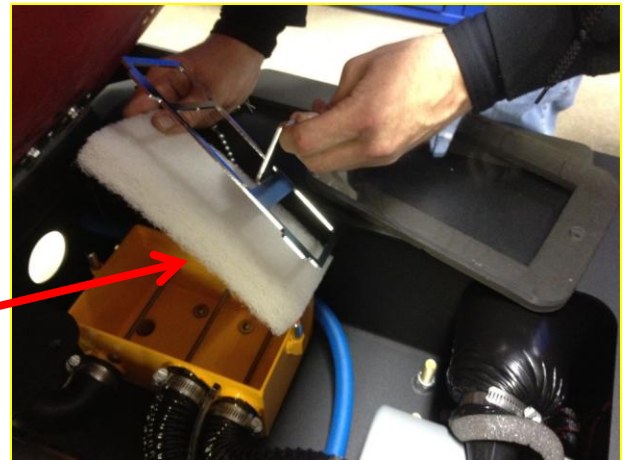
Pack of 5 Filters: *Available from our Parts Department under 370-4087. New machines come with a bag of 4.*

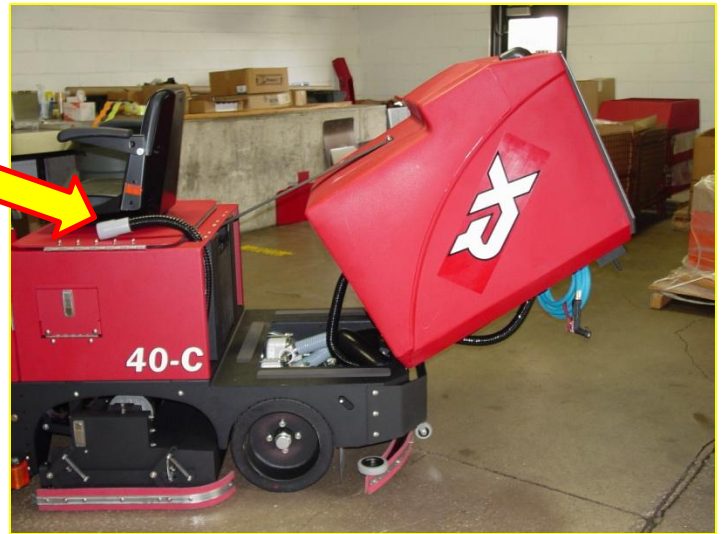
Prior Hose Location: *Was common for customers to have the hose pinched between the tank and the battery box, which reduces airflow and squeegee performance. It also routed close to the cylindrical hopper, allowing for small leaks at a difficult to trouble shoot point.*

Relocating the vacuum hose from the front to the back will reduce the potential for damaged hoses and reduced drying performance.

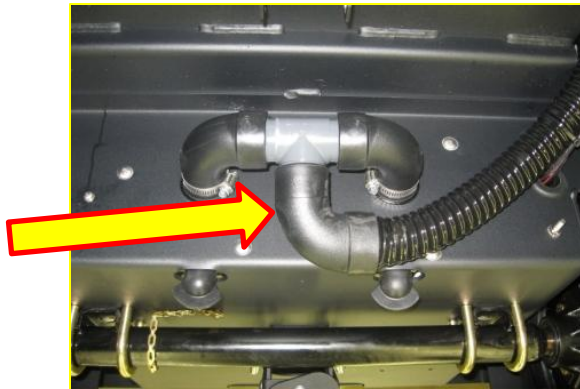
New Hose Location: *The vacuum hose is missing from the front, and now installed at the rear of the tank. This makes tipping the tank back for service easier and reduces crushed hoses.*

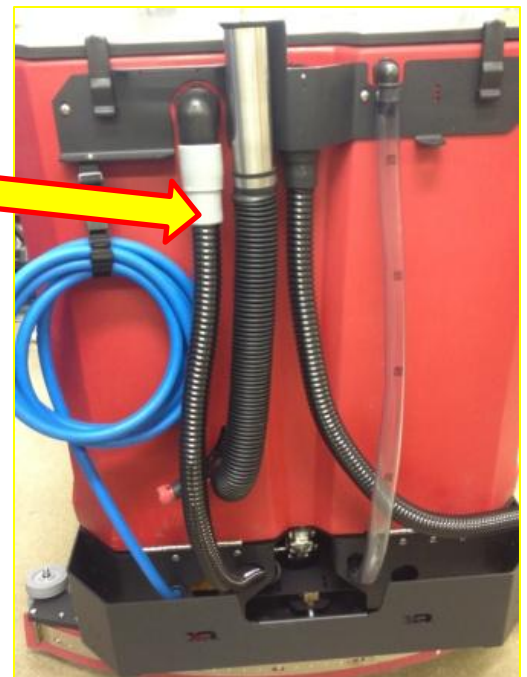
New Wider Bracket: *This is part#: 370-1123 and it creates a barrier between the incoming dirty water hose from the squeegee and the stainless screen the float ball is inside. We found customers wouldn't properly install the hose into the drain saver basket.*

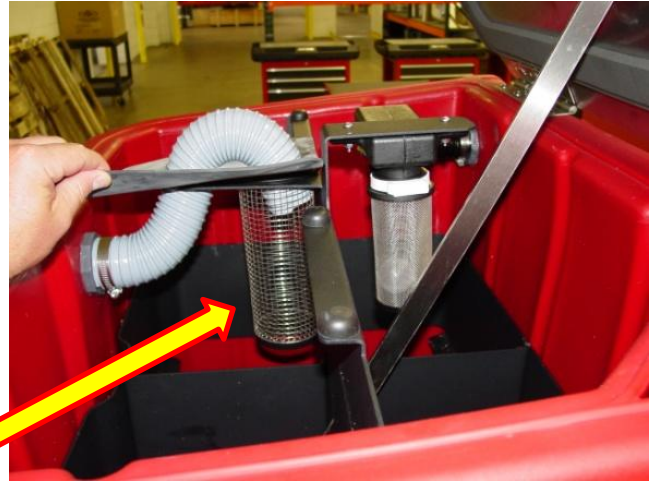
You can see from the attached photo that when the hose is out of the basket, it was pointed directly at the screen. Also, so customers remove the drain saver basket completely. It is important that the incoming squeegee hose is properly pointed down through the hole as shown in the bottom image.

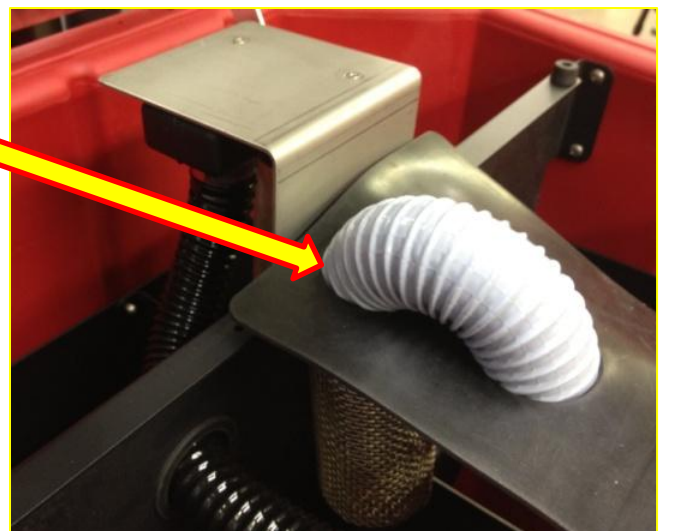
Properly Installed Hose: *When installed correctly the hose is directing the dirty water into the basket, and on the opposite side of the baffle.*
