DATE OF BULLETIN:

8-30-2017

MODELS AFFECTED:

SPORT	PRO
CARBON	GTX (Standard Two-Tank Assembly Only)
HERO	XR (Standard Two-Tank Assembly Only)
<i>Retired Models</i>	
RS

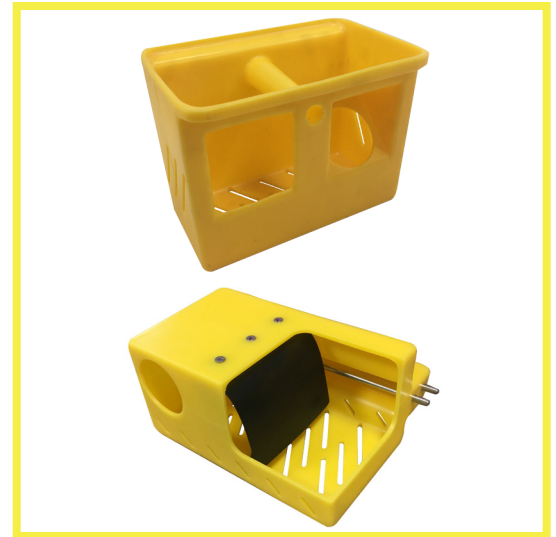
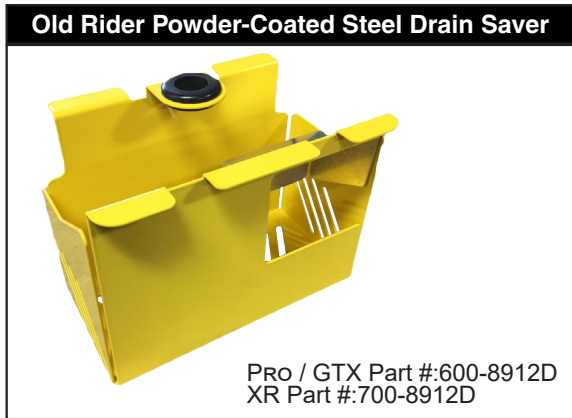
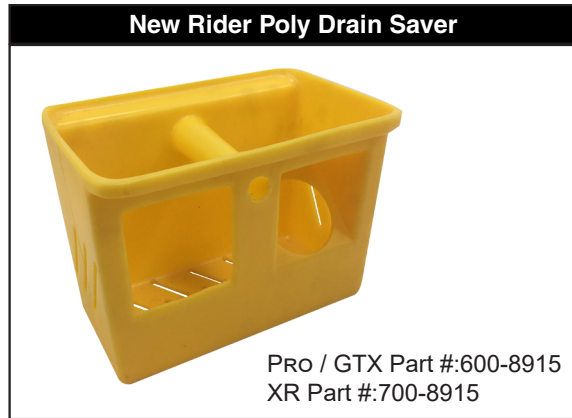
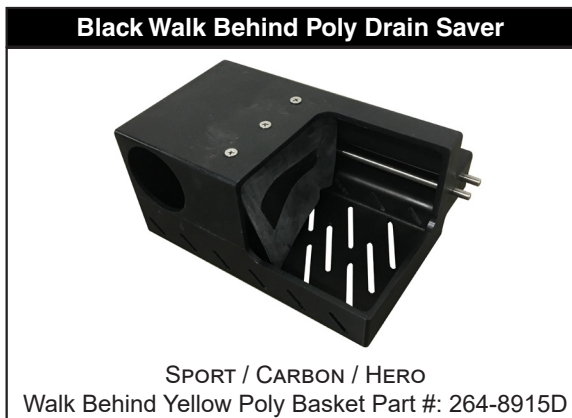
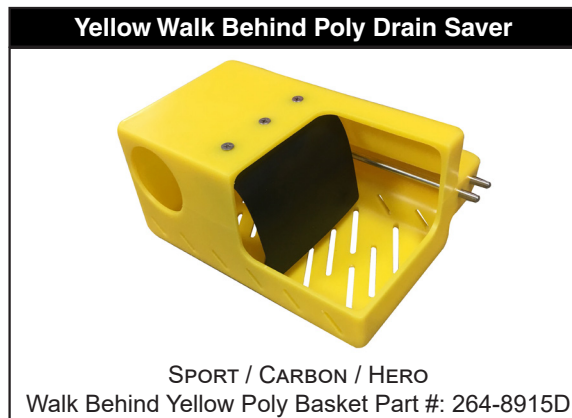
Chipping of powder coating. Drain Saver falling inside of recovery tank.

On August 1st, 2017 the Drain Saver Basket on our Rider Scrubbers switched from Powder-Coated Steel to Corrosion Resistant Yellow Poly. The CARBON switched to a Yellow Poly for increased visibility. The other walk behinds will follow at a later date.

PRO / GTX Part #: 600-8915 (LIST \$56.40)
 XR Part #: 700-8915 (LIST \$56.40)
 Walk Behind Yellow Poly Basket Part #: 264-8915D (LIST \$83.36)
