PCB-638

MODELS AFFECTED:
RECON
MICROMINI

SCOPE OF BULLETIN:
New Stainless Steel Baffle standard
New drop-in Float-ball screen and enlarged Float-ball
New white Vacuum Filter
Retractable front fill-hose

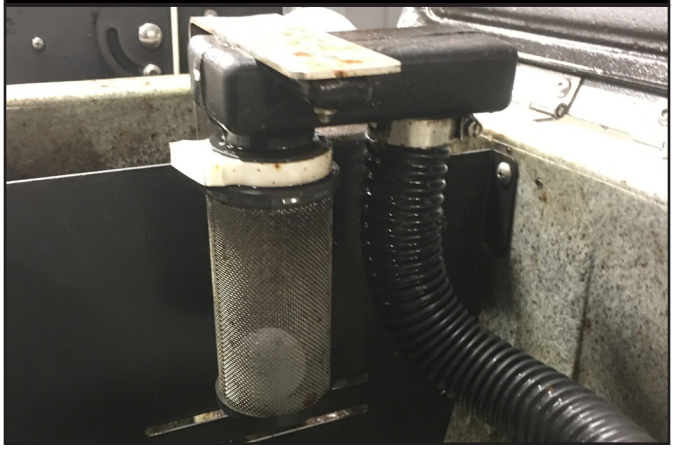
Old Clip-On Float Ball

New Drop-In Float Ball

2. New Drop-In Float-Ball Screen to prevent assembly from dropping into tank assembly and enlarged Float-Ball to prevent the potential soap foam from getting into the Vacuum Motor. Enlarged 2" vacuum intake hose for better airflow.

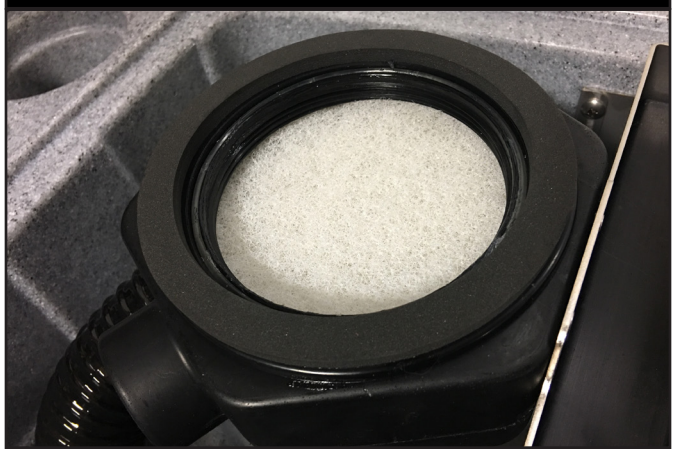
Dirty Filter

Clean New Filter

3. New white Vacuum Filter as an added layer to prevent potential soap foam or small particulates into the Vacuum Motor.
