DATE OF BULLETIN:

10-17-2017

PILOT-HD GTX XR

Shroud Wipers moving out of adjustment over time

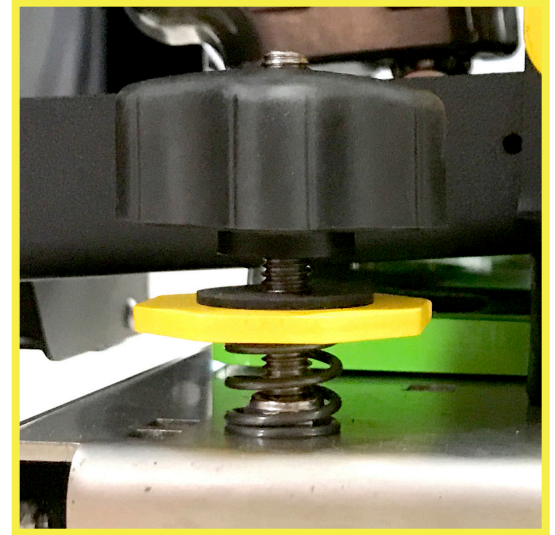
Spring Under Shroud Adjustment Knob

All Disk Rider Scrubbers include new Rubber Washer (Part #: H-4440040) and Support Spring (Part #: 4-386) surrounding the Shroud Adjustment Knob. The Spring that is supported by the Deck, ensures that the Adjustment Knob will not self adjust down over time from machine usage. The Rubber Washer that now sits on top of the Adjustment Knob is to reduce rattle with the machine in operation.
