Product Change Bulletin

6-21-2011

Magnum

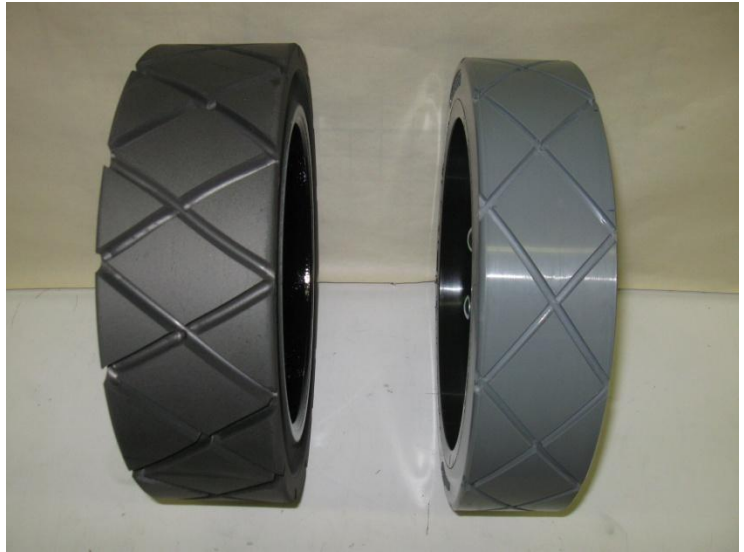
Solid tires have traction loss

We decided to go with a different tread pattern and material to improve traction on various floor types. The improved tread pattern allows more gripping power even on wet floors. Also the grey tire is an aesthetic improvement.

Black or grey metal rim tire

Prop the machine up on a wooden block or something that can support the weight of the machine on its frame. Remove the nuts holding the tire on, knot out the studs from the transaxle and replace with the longer studs. Make sure the bushings are installed on the wheel opposite the transaxle. Slide wheel onto studs, add the Nylocks and tighten.
