PRO GTX XR

Shroud Wipers moving out of adjustment over time

SCOPE OF BULLETIN:

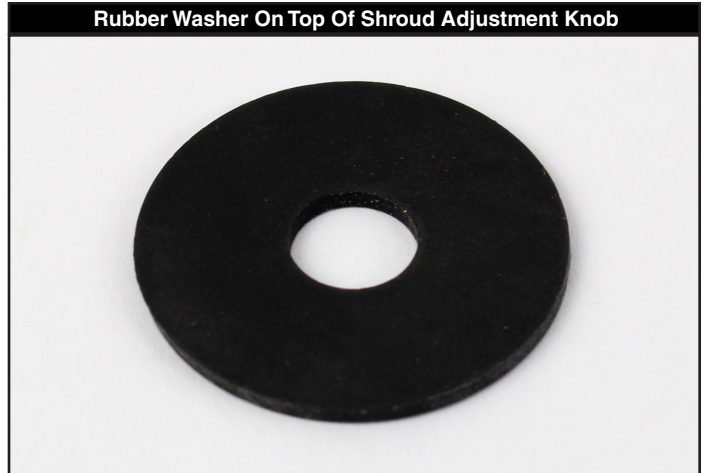
Rubber Washer On Top Of Shroud Adjustment Knob

All Disk and EDGE Rider Scrubbers include new Rubber Washer (Part #: H-4440040) and Support Spring (Part #: 4-386) surrounding the Shroud Adjustment Knob. The Spring that is supported by the Deck, ensures that the Adjustment Knob will not self adjust down over time from machine usage. The Rubber Washer that now sits on top of the Adjustment Knob is to reduce rattle with the machine in operation.
