XR Models

Tank warping due to heat

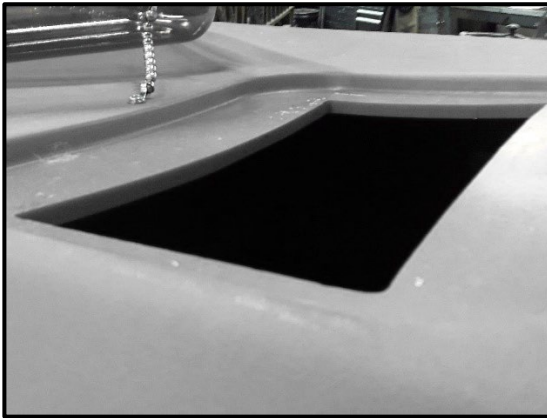
*(Warping)*

We are now installing a metal support bracket on our XR Recovery tanks to prevent warping in the field. Should a tank warp, please contact [warranty@rpscoperation.com](mailto:warranty@rpscoperation.com) and we will work with you to install XR Recovery Tank Support Kit - #700-7015D.
